TRANSFORMER OILS AND REMEDIAL PROCEDURES ON CORROSIVE SULFUR EFFECTS

KARTHIKEYAN

Department of Electrical and Electronics Engineering (Marine), AMET University, Chennai Tamil Nadu, India

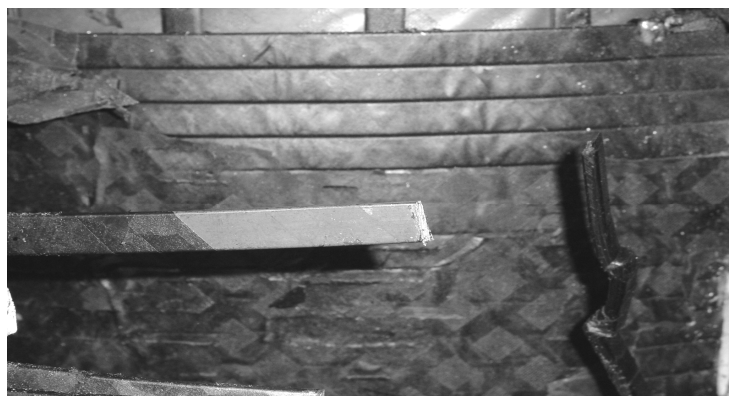
Figure 1: Copper Sulfide Deposit on a Copper Conductor at a Failure Site

A standout amongst the most widely recognized sorts of destructive sulphur related transformer disappointment in the field is observed to be because of high temperatures in the windings, regularly coming about

because of insufficient cooling of the windings or configuration imperfections. The event of copper sulphide on the copper channels and the Kraft paper tapes contiguous they speaks to conceivable locales of overheating in either a sound winding or the other wellspring of overheating in an officially broken winding. Examination of fizzled transformer windings gives confirm that numerous disappointments happen either in close region to the top bit of the winding where the temperature is most noteworthy, or in zones of the winding where inadequate cooling results in a higher level of cellulose chain scission than what can be foreseen on the premise of lifespan of the unit in administration. These high-temperature problem areas every now and again uncover copper sulphide stores unequivocally proposing that in these disappointments, destructive sulphur is either the primary driver of the deficiency or at all a critical contributing component Maina et al. (2009) Scatiggio et.al (2011) Scatiggio et.al (2009, May).
